Tree Survey

4 x Corsican Pine trees, Cemetery, Blockley

Prepared for: Blockley Parish Council

Date: 26th July 2011

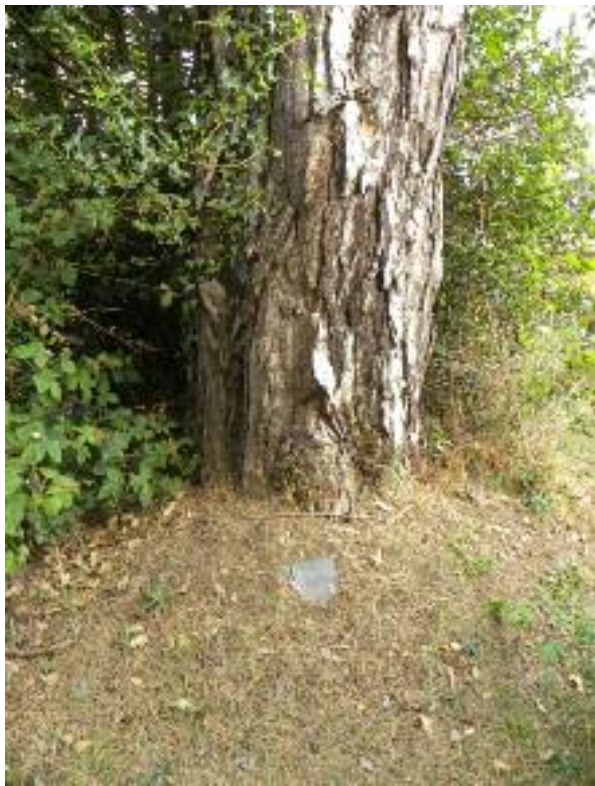
The root plate of this tree appears in good condition, with no signs of uplift/movement. The lower stem is solid with no visible signs of rot or fungus, there is evidence of tight Ivy growth, which has since been removed.

T1 root plate and base

- Crown reduction to just below original pruning cuts to eliminate any rot
- Remove deadwood
- Possible removal of back limb over cemetery
- 15% reduction of most weighted limbs over the road to reduce weight
- Monitor

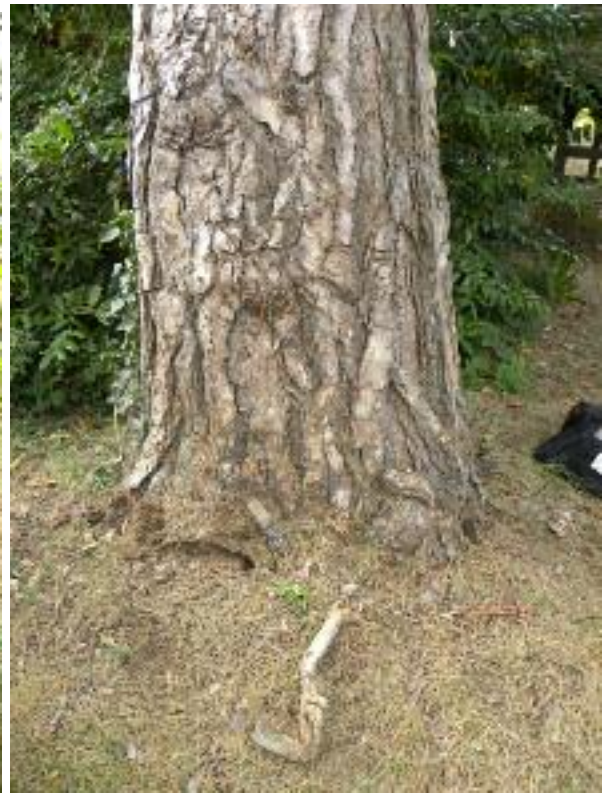
The rootplate of this tree appears in good condition, with no signs of uplift/movement. The lower stem is solid with no visible signs of rot or fungus, there is evidence of tight Ivy growth, which has since been removed. The lower stem is solid with no visible signs of rot or fungus, there is evidence of tight Ivy growth, which has since been removed. A solid single stem leans heavily out towards the road. There are no signs of movement and it appears that the tree has always had this habit and as a result had put on reaction wood growth to support it and does not appear to be a concert at this time.

T2 root plate and base

- Crown reduction to just below original pruning cuts to eliminate any rot (40%)
- Remove deadwood
- 15% reduction of most weighted limbs over the road to reduce weight
- Monitor

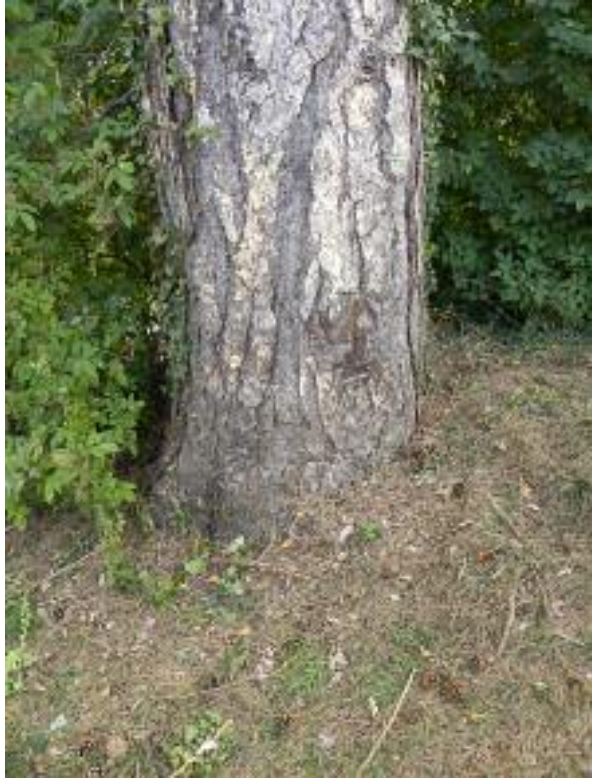
The rootplate of this tree appears in good condition, with no signs of uplift/movement. The lower stem is solid with no visible signs of rot or fungus, there is evidence of tight Ivy growth, which has since been removed. The lower fork has evidence of included bark and could be a weak point. Previous

T3 root plate and base

- Crown reduction to just below original pruning cuts to eliminate any rot
- Remove deadwood
- 15% reduction of most weighted limbs over the road to reduce weight
- Monitor decline
- Renew cable bracing

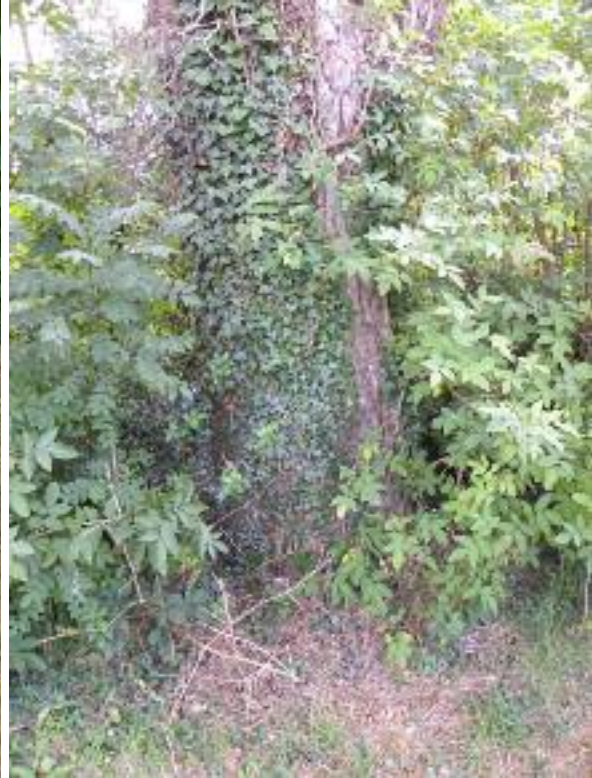
The rootplate of this tree appears in good condition, with no signs of uplift/movement. The lower stem is solid with no visible signs of rot or fungus, there is evidence of tight Ivy growth, which has since been removed. The main stem splits into 3 leaders, one union at 3m and one at 10m. The union at 3m has rot present and the leader which extends over the cemetery has had a significant limb shed out recently, this could be evidence of an unknown pathogen not picked up on in this report or just heavy weight bearing.

T4 root plate and base

- Remove tree

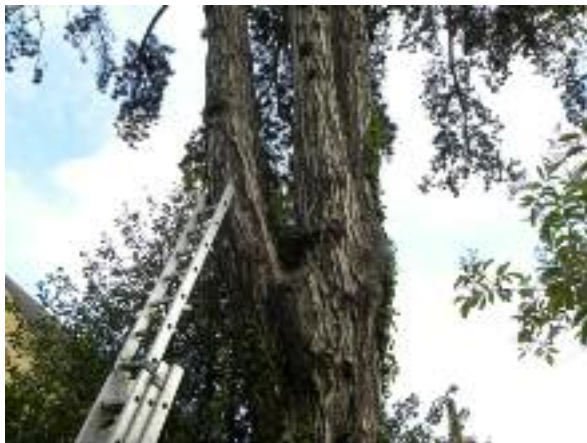
The main stem splits into 3 leaders, the union appears to be in good condition with no signs of included bark, strong reaction wood is present. A 4th leader extends on the Cemetery side from a fork higher up, this fork shows evidence of included bark and could be a weak point, it is also not cable braced. An old pruning wound on this stem is beginning to show signs of rot.

T1 3 way fork

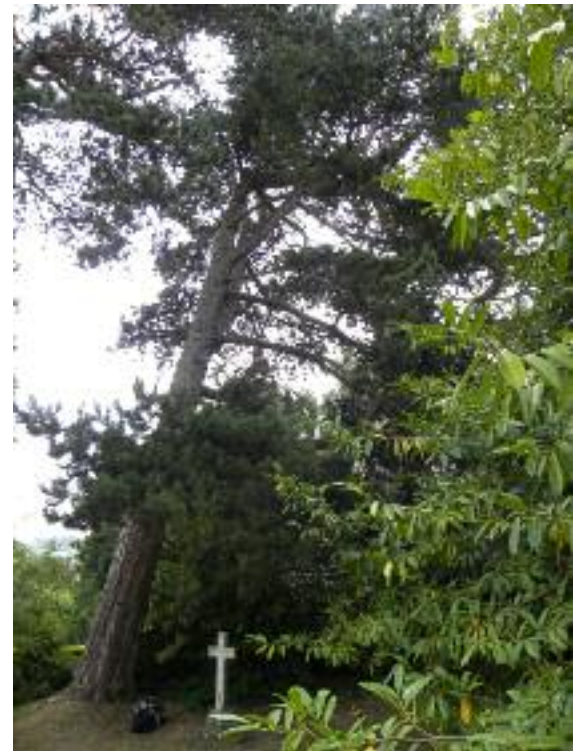
Overall, this tree looks to be in a stable condition (in terms) of the lean, however, the stimulated heavy regrowth and adverse affects of past management suggest some remedial pruning works, see below.

T2 lean toward the road

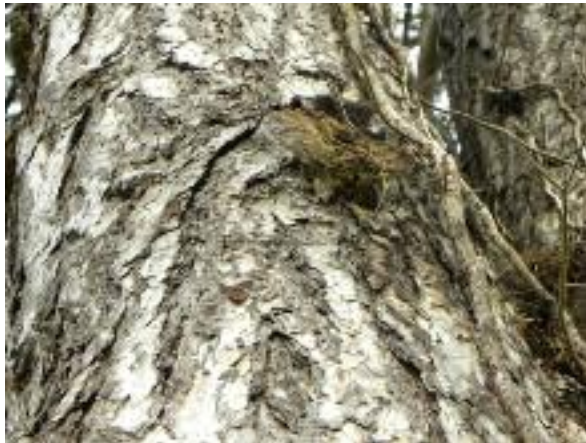
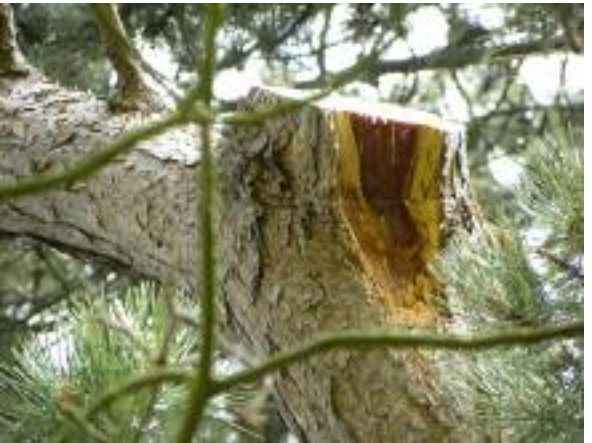
Previous crown lifting is evident and the old pruning cuts have crystallised sap/resin present, and some are showing signs of rot. Previous pruning in some cases has not been back to the branch collars and this has restricted callous growth.

Crystallised resin

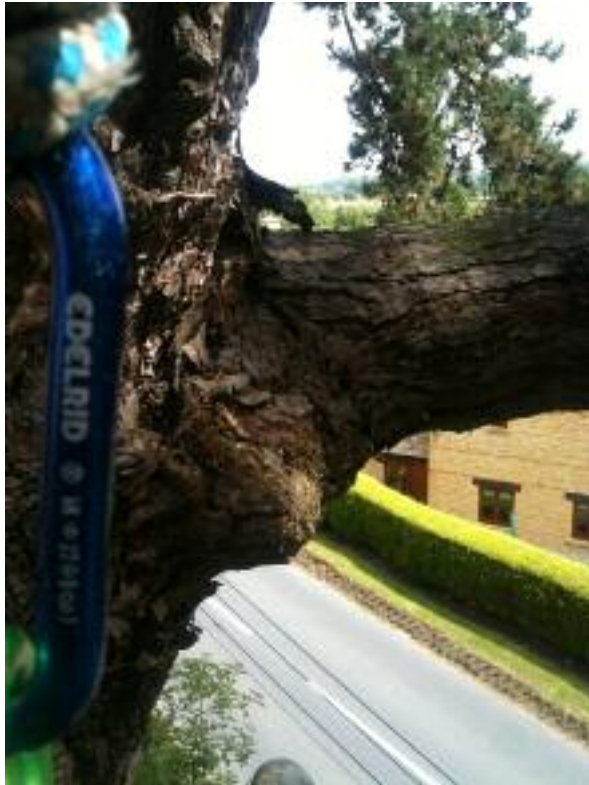
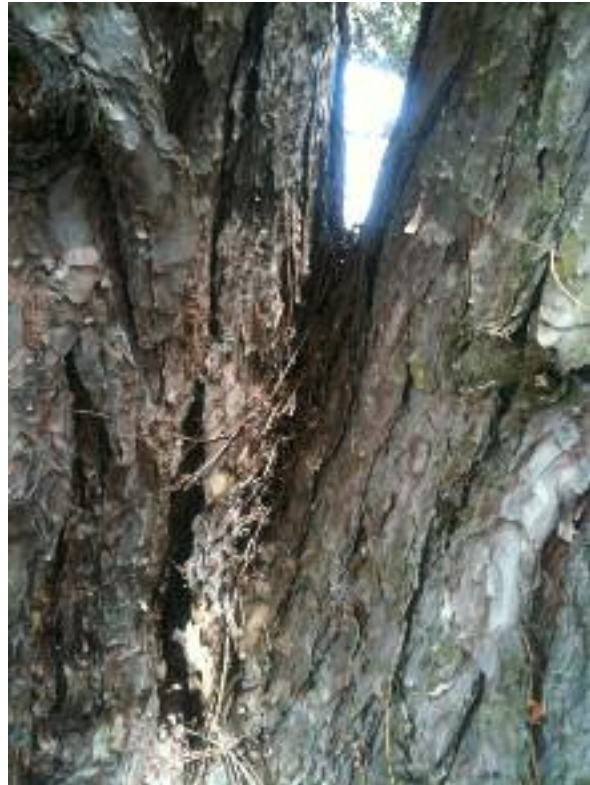
There are signs of dieback in the upper canopy and there is major and minor deadwood throughout. A large torn out limb is hanging and wedged into other limbs and although not an immediate danger, should be removed with some urgency.

Overall, this tree has multiple problems and is in decline, is shedding significant limbs. The main fork is potentially weak and the chances of these cleaving apart are high. This tree should be considered for removal for health & safety reasons.

T4. Shed limb

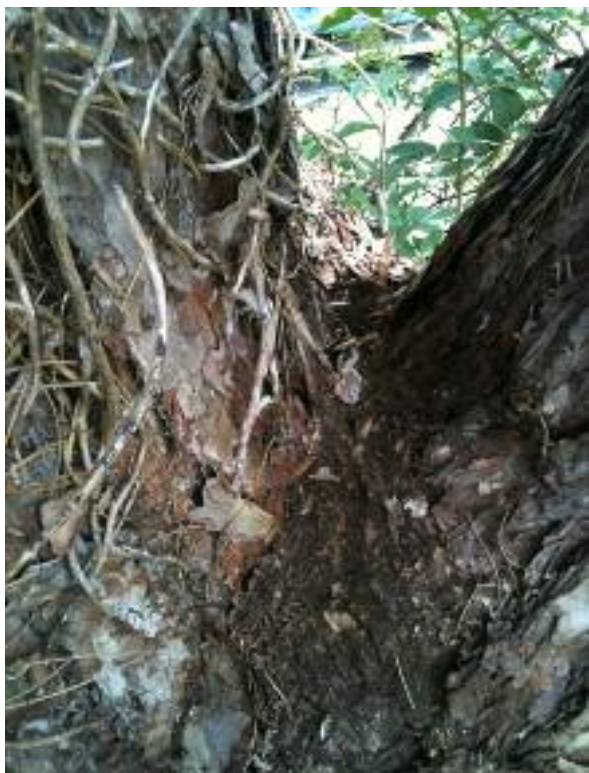
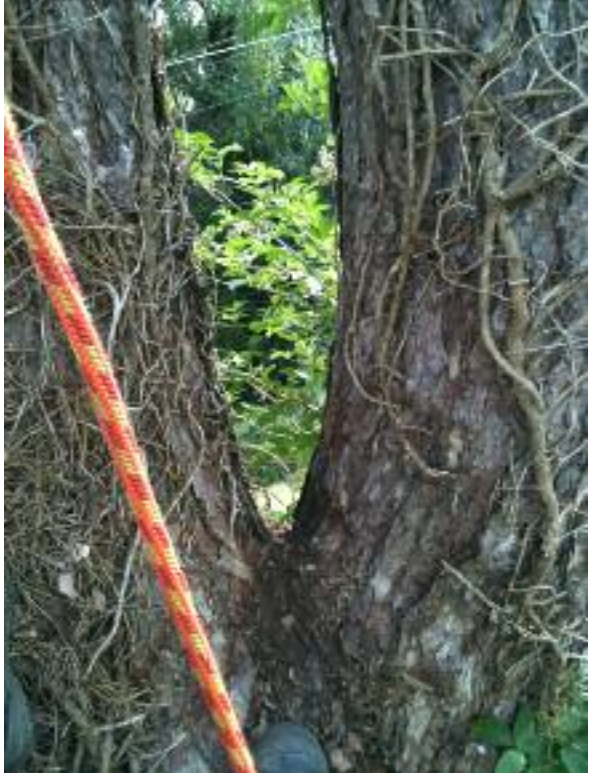
All unions on this tree appear solid although some of the past reduction and lifting cuts, as T1. are showing signs of rot. Again substantial regrowth extends from these points up and over the road which contain a significant amount of weight.

T2. Some rot present

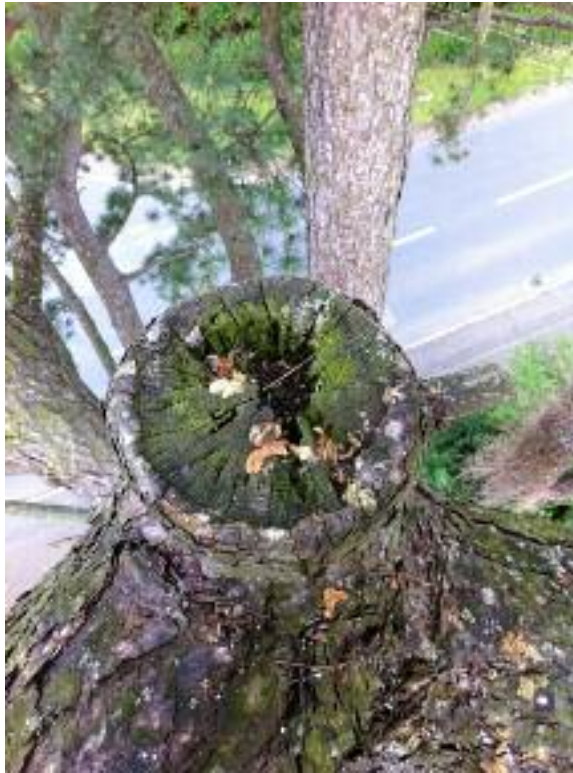
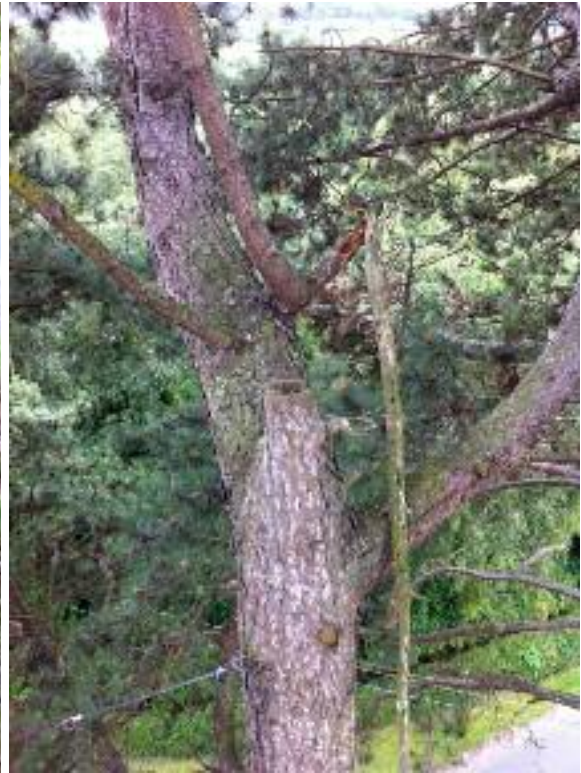
T4. Rot present

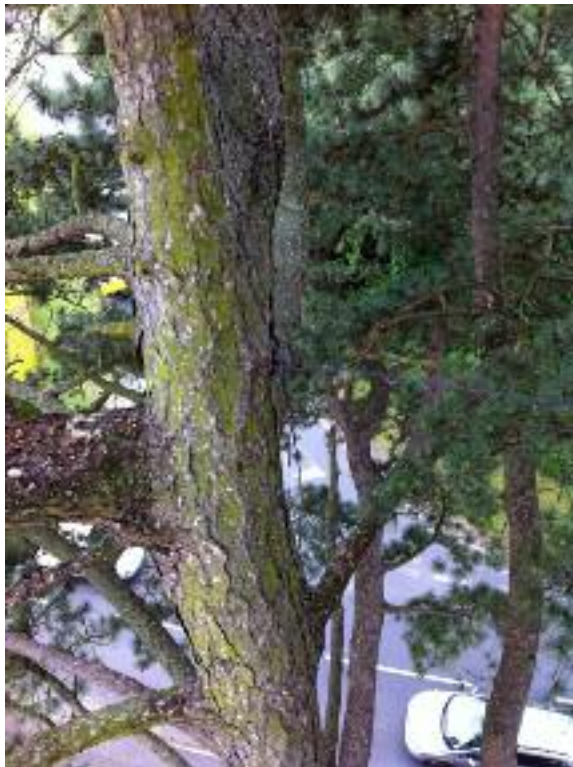
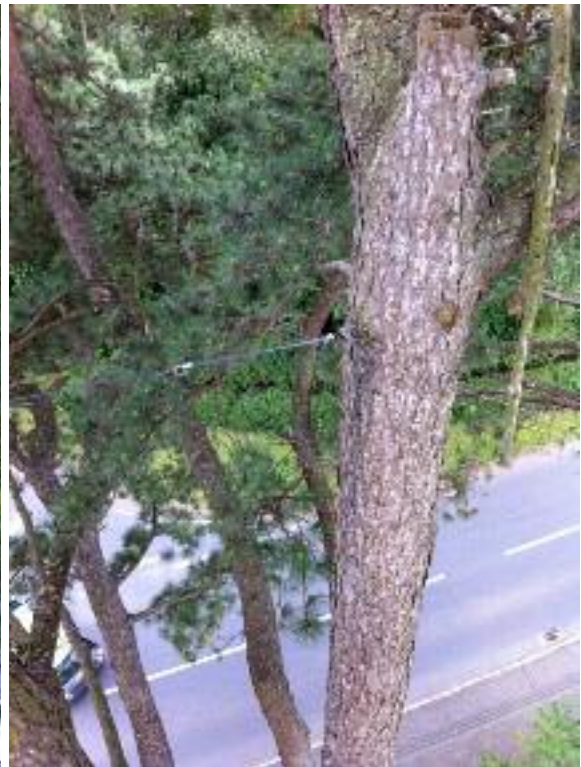
Severe pruning cuts on the main stems suggest a past reduction in height. These cuts were left as 'step cuts' and are showing signs of rot in places. Stimulated and heavy regrowth extends from these points, which could become weak.

Old reduction cuts, rot present

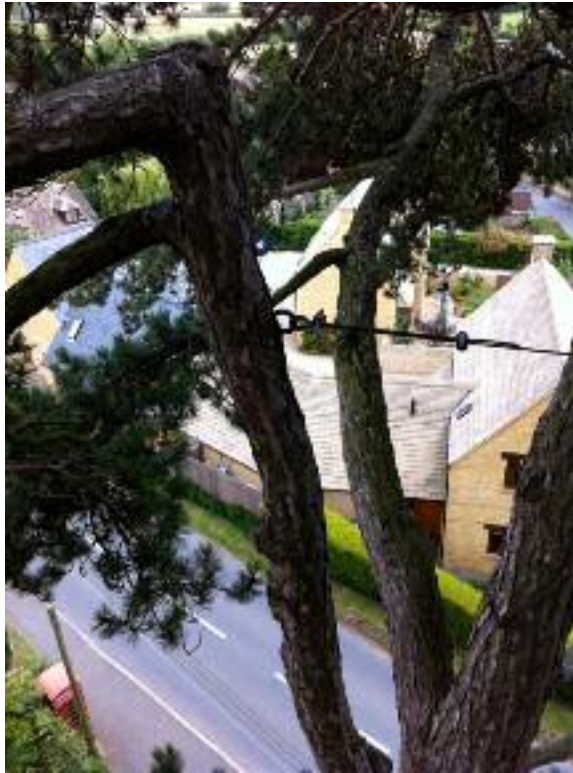
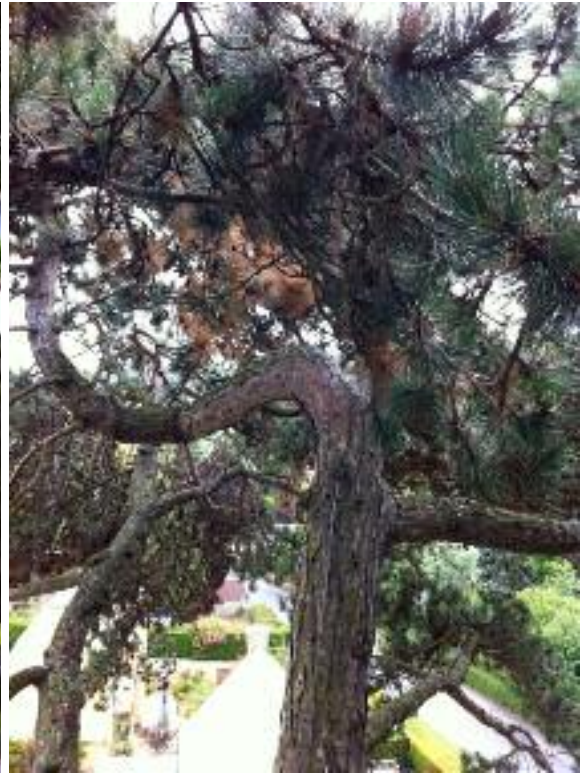
The stems have been cable braced and this system is showing signs of age, the tree is growing around the anchor points and the metal is beginning to rust. The bracing appears to be doing a useful job at this time and although deteriorating, is operating as a useful backup.

The existing cable bracing is broken and serves no purpose at this time, although should be replaced with a more modern durable system, which are now available.

Cable bracing

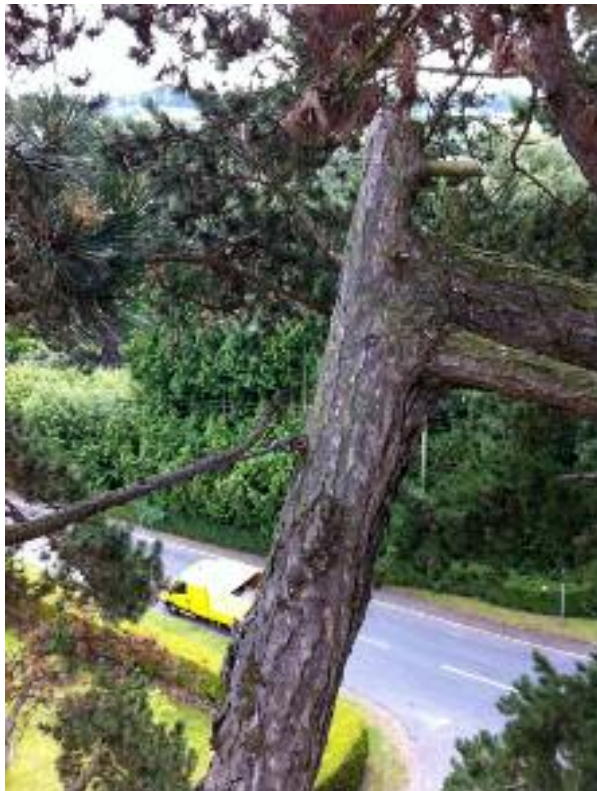
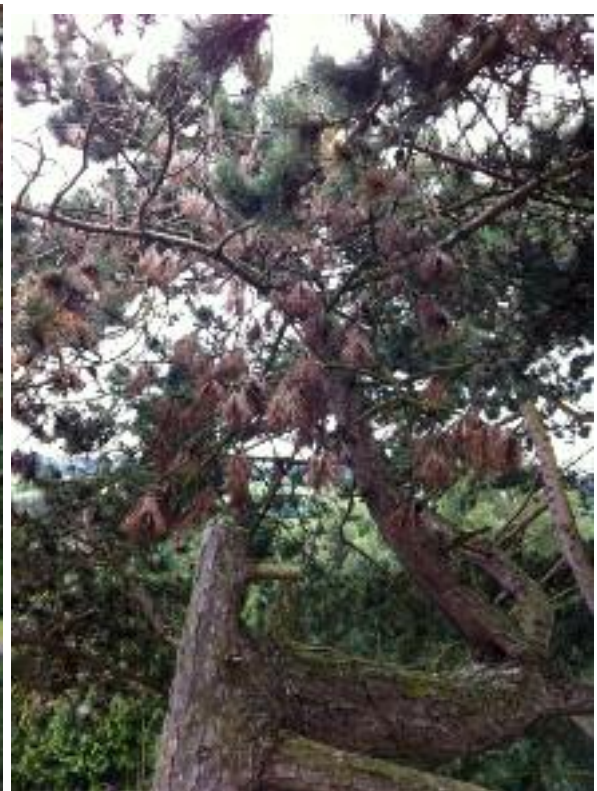
There are signs of dieback in the upper canopy and there is minor deadwood throughout. A torn out limb is hanging but still partially attached and although not an immediate danger, should be removed.

There are signs of dieback in the upper canopy and there is minor deadwood throughout. It should be mentioned that this tree appears to have a much sparser canopy with fewer needles than the other trees; this may be a symptom of further decline and should be monitored on a regular basis.

Dieback in upper canopies

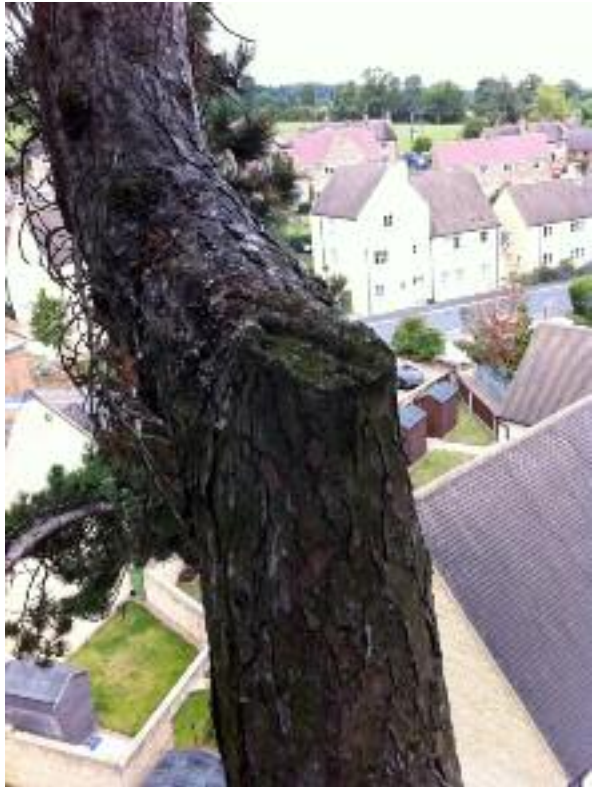
Severe pruning cuts on the main stems suggest a past reduction in height. These cuts were left as 'step cuts' and are showing signs of rot in places. Stimulated and heavy regrowth extends from these points, which could become weak.

Regrowth from previous cuts

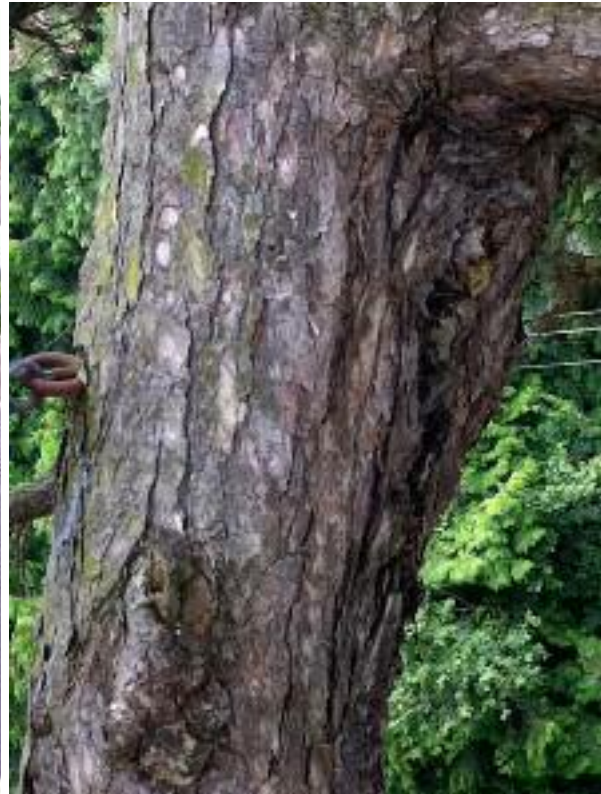
Bracing attachments aging
