Tree Survey

4 x Corsican Pine trees, Cemetery, Blockley

Prepared for: Blockley Parish Council

Date: 26th July 2011

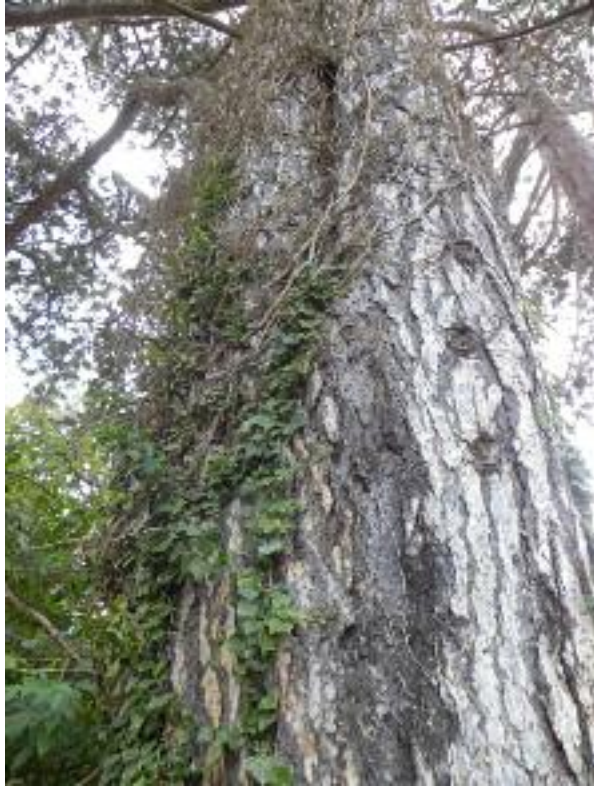
Previous crown lifting is evident and the old pruning cuts have crystallised sap/resin present, and some are showing signs of rot. Previous pruning in some cases has not been back to the branch collars and this has restricted callous growth.

Crystallised resin

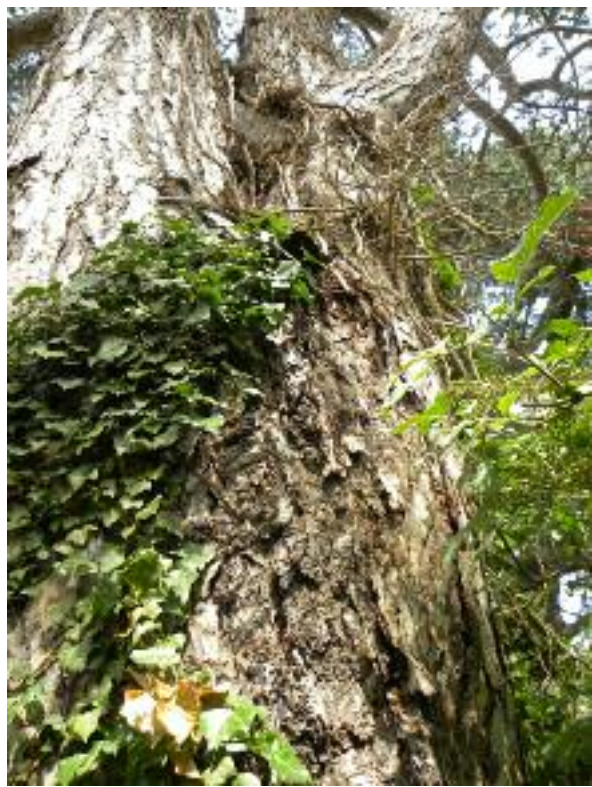
T4. Shed limb
